# SEAL STRENGTH AND SEALED PACKAGE TESTING REPORT

| Project Number / Job<br>Number | FT-26-XX / 12345 |

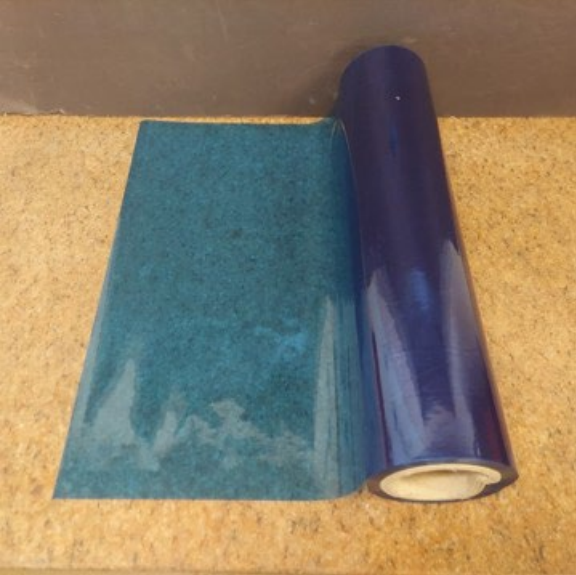
| Supplied Pouches - Front | Corrugation Example |

The seals on the supplied pouches of product had some minor distortions usually associated with sealing at high temperature relative to the seal temperature range for the film.

Overall, the packages provided seemed to be formed with few defects out of a high-quality film.

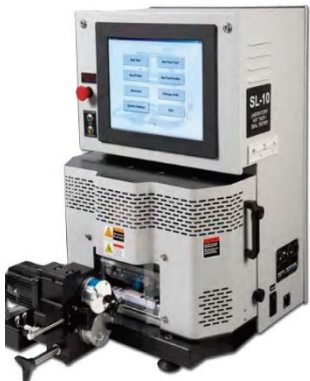
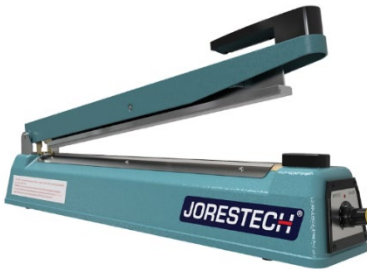
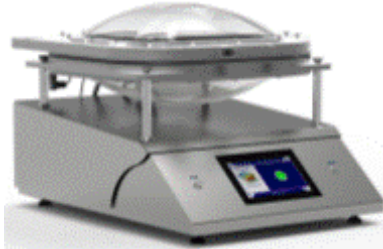
| TMI – Hot-Tack Tester and Seal Tester<br>SL-10 75-50 | Technopack – MS-405<br>Impulse Sealer | Inficon – Contura S400 |

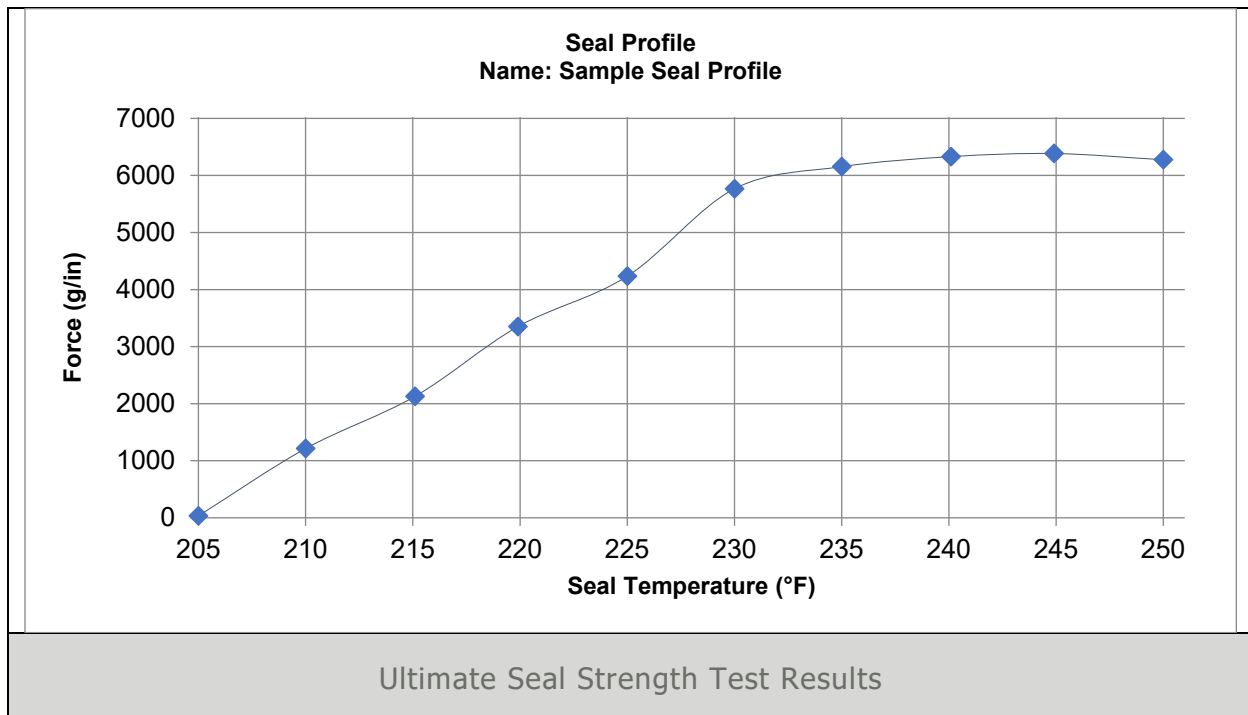
### Ultimate Seal Strength Profile Tests

| Starting Temp: | 205.0° F [96.1° C] | Ending Temp: | 250° F [121.1° C] |
| Seal Length: | 1.000 in [25.4 mm] | Pressure Request: | 100.0 PSI [689.5 kPa] |
| Seal Width: | 0.750 in [19.1 mm] | Jaw Pattern: | Steel Upper/ |
| Dwell Time: | 0.50 sec | Peel Velocity: | Poly Lower |
| Cool Delay: | 0.00 sec | Selection Method: | 0.25 in/sec |

The film has a steady increase in seal strength until it reaches the material limit of about 6000 g/in at about 235°F [112.8°C]. At this level the seal strength is limited by the elongation of the material.

Based on the results of the Ultimate Seal Strength Test, the optimal seal temperature range is likely above 235°F [112.8°C].

Seal testing was performed to find the temperature range with the highest Hot Tack strength and Ultimate Seal Strength. The Ultimate Seal Strength consistently increased with the increasing temperature, while the Hot Tack Strength was highest between 265° F [129.4° C] and 295° F [146.1° C].

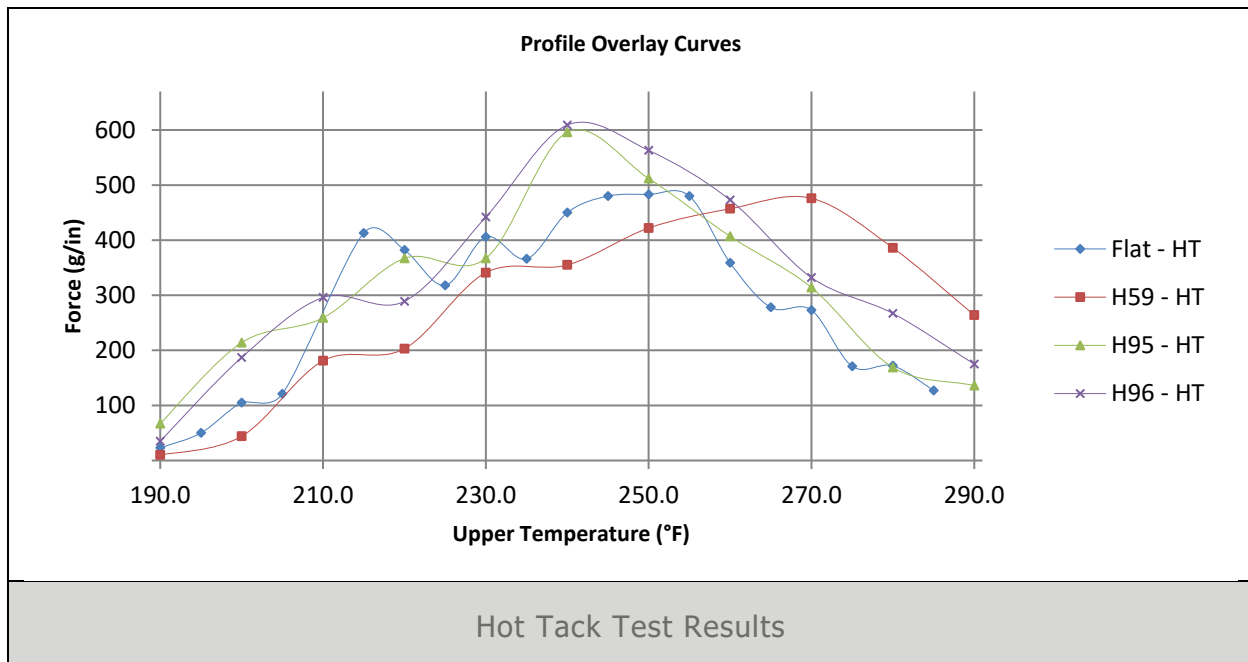
### Hot Tack Profile Test

| Starting Temp: | 190.0° F [87.7° C] | Ending Temp: | 290° F [143.3° C] |
| Seal Length: | 1.000 in [25.4 mm] | Pressure Request: | 100.0 PSI [689.5 kPa] |
| Seal Width: | 0.750 in [19.1 mm] | Jaw Pattern: | Varies |
| Dwell Time: | 0.50 sec | Peel Velocity: | 0.25 in/sec |
| Cool Delay: | 0.00 sec | Selection Method: | Initial Peek |

The coarse-pitch H95 and H96 profiles had better Hot Tack seal initiation at lower temperatures and better peak hot tack temperatures than the flatter tooling setups (the flat and H59 setups). These coarse profiles also had a narrow peak with a sharp dropoff at higher temperatures, where the flatter/finer setups had a broader window, with a slower dropoff at higher temperatures. The variability of the material thickness may have affected the flat setup the most as it had the largest inconsistencies in the Hot Tack Strength increases.
